Givaudan Roure Corporation

Remedial Action Report for
Sewer Decommissioning
Clifton, New Jersey

February 2000

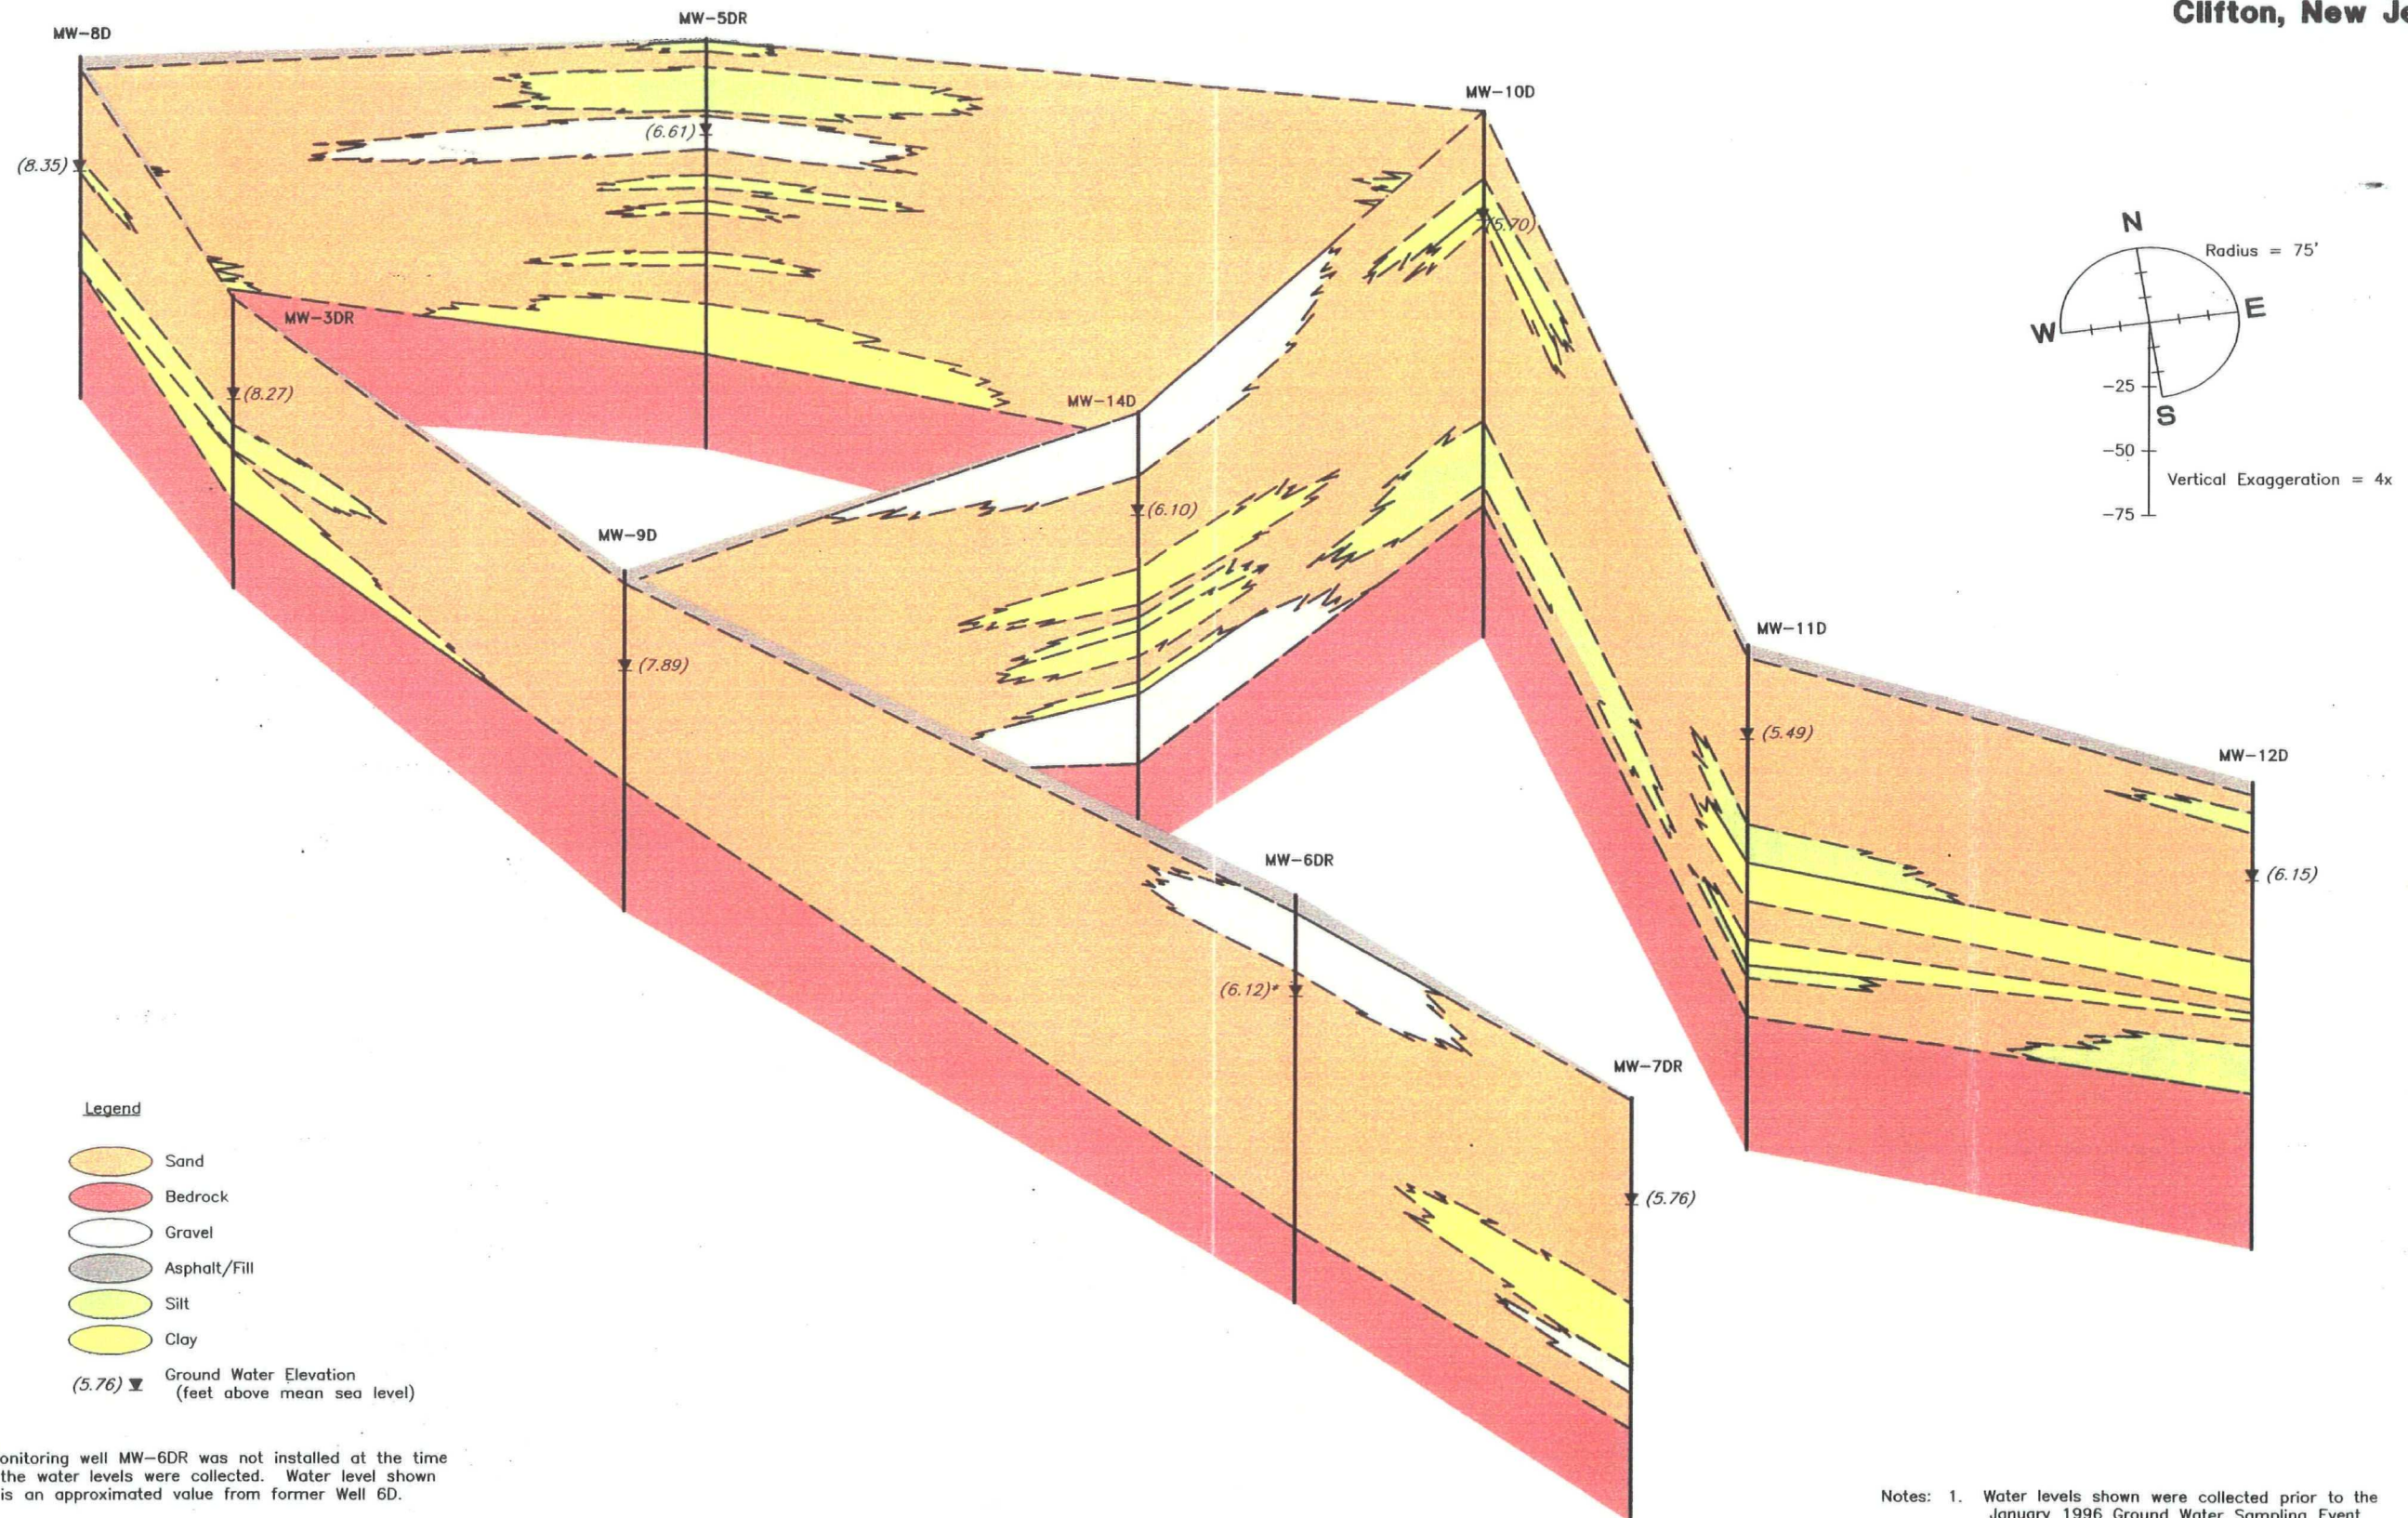
Figure 2-5
Site Geology Fence Diagram
Givaudan Roure Corporation
Clifton, New Jersey

Two aquifers are being monitored by the site well network: the shallow and intermediate wells monitor the unconsolidated overburden aquifer while the deep wells monitor the shallow bedrock aquifer.

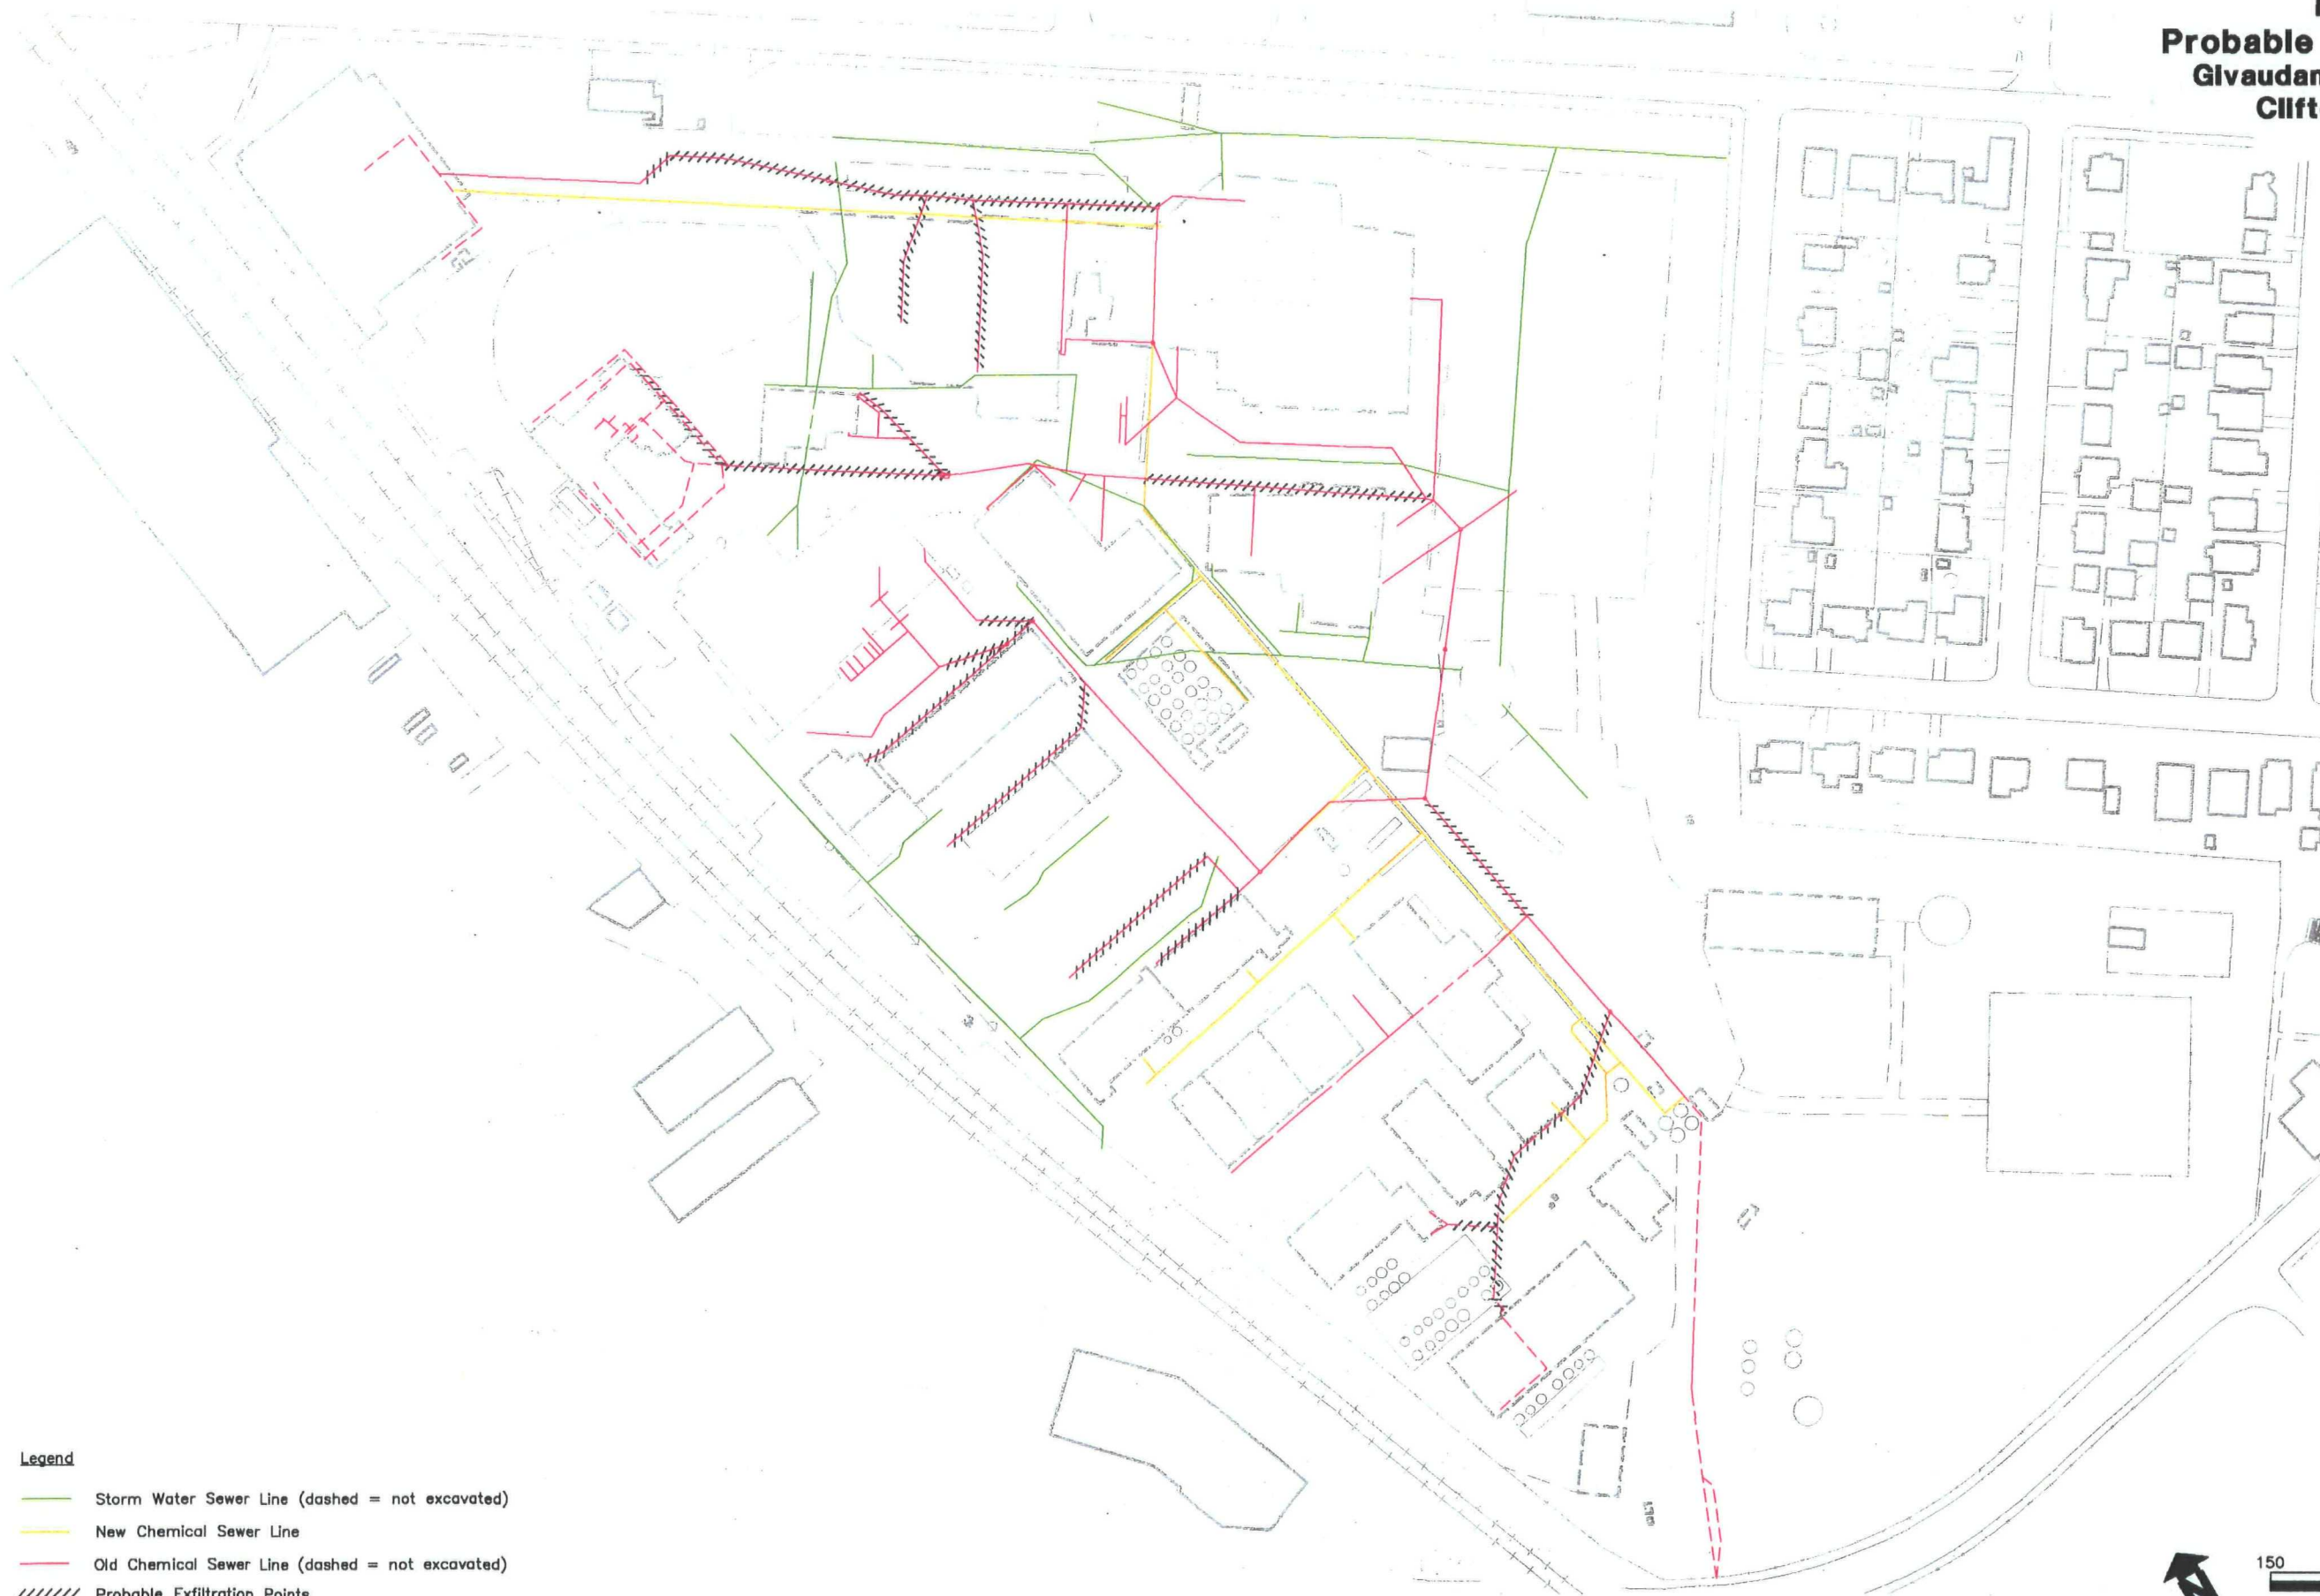
Figure 2-7
Probable Exfiltration Points
Glvaudan Roure Corporation
Clifton, New Jersey

poor condition as either severely eroded or broken pipe. The results of the survey, presented in a report titled *Chemical Sewer Investigation* (CFM, September 1983), were used in part to prepare the scope of work completed during the Phase II Soil Investigation (ERM, 1995). A copy of the September 1983 report prepared by CFM is included in Appendix A.

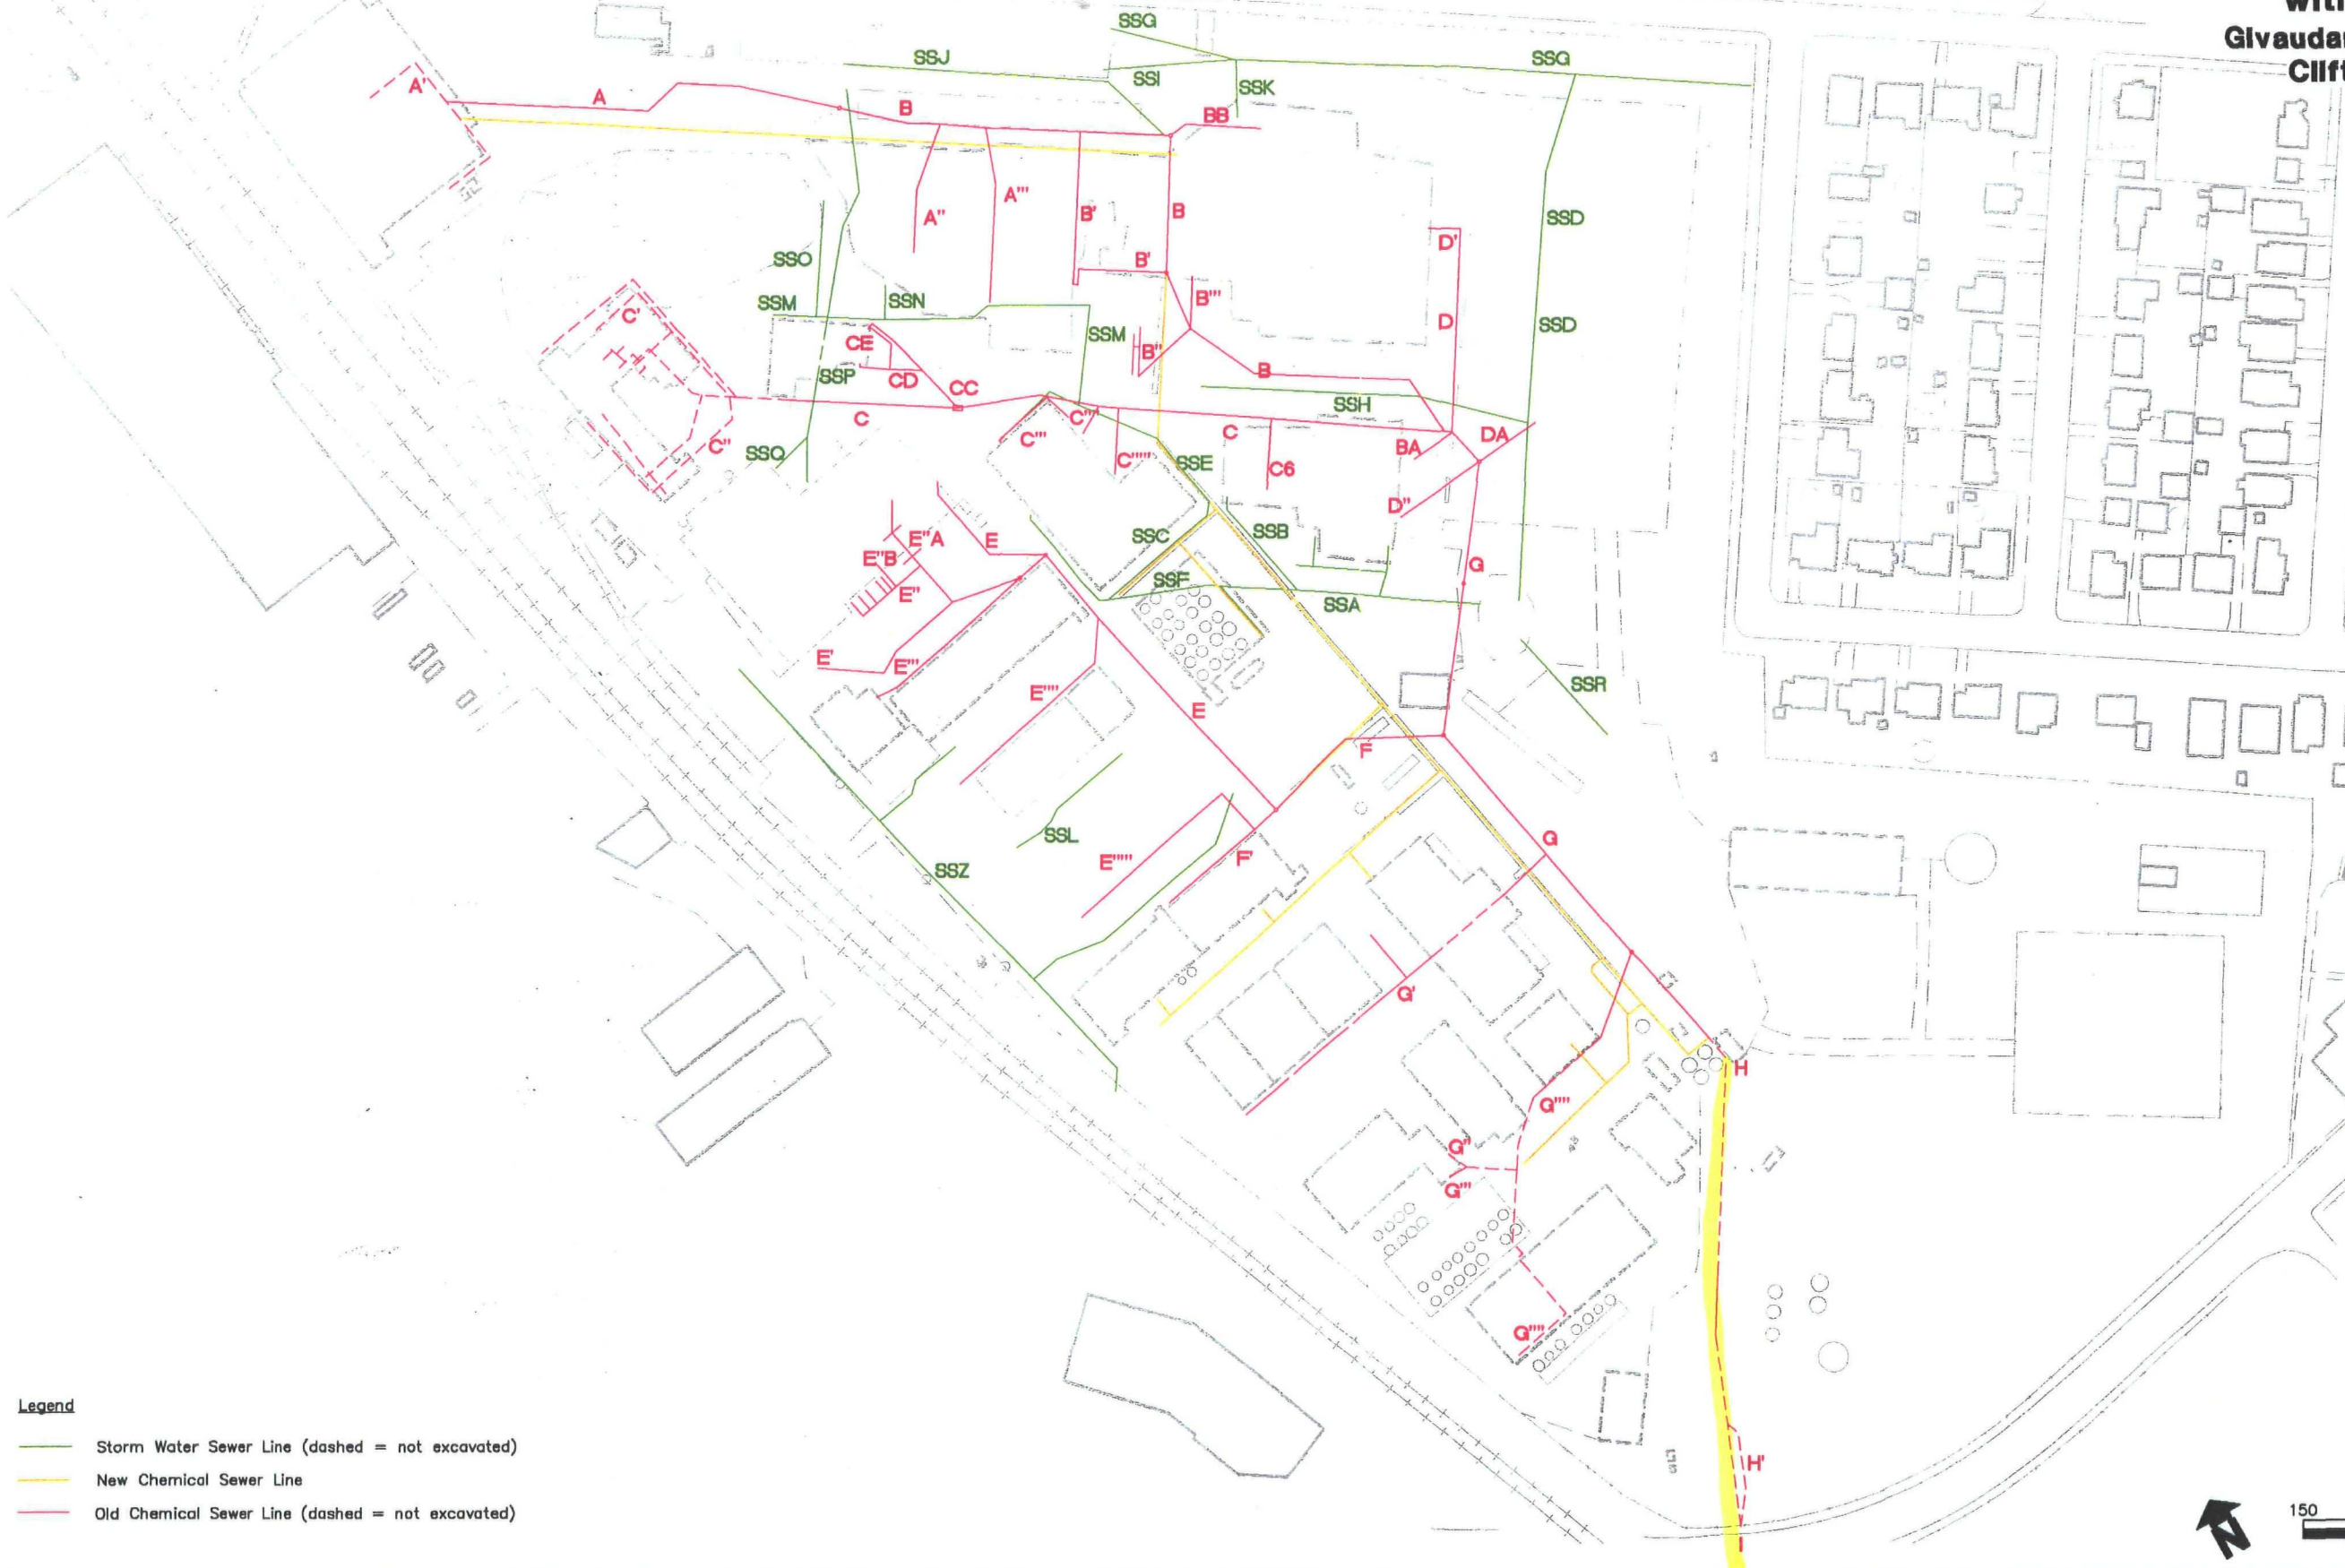
Figure 3-1
Sewer Location Map
with Designations
Glvaudan Roure Corporation
Clifton, New Jersey

The location of the sample within the excavation was represented by a "sw" or a "b" designation, for "side wall" and "bottom" respectively. To build on the example started above, a sample named "A-30-SW" would represent a sample collected from the "A" line, a distance of 30 feet from the beginning of the excavation, collected from the excavation sidewall.
